Exhibit C-1: Development Plan

Development Plan

PETERSEN RANCH MITIGATION BANK LEONA VALLEY, LOS ANGELES COUNTY, CALIFORNIA

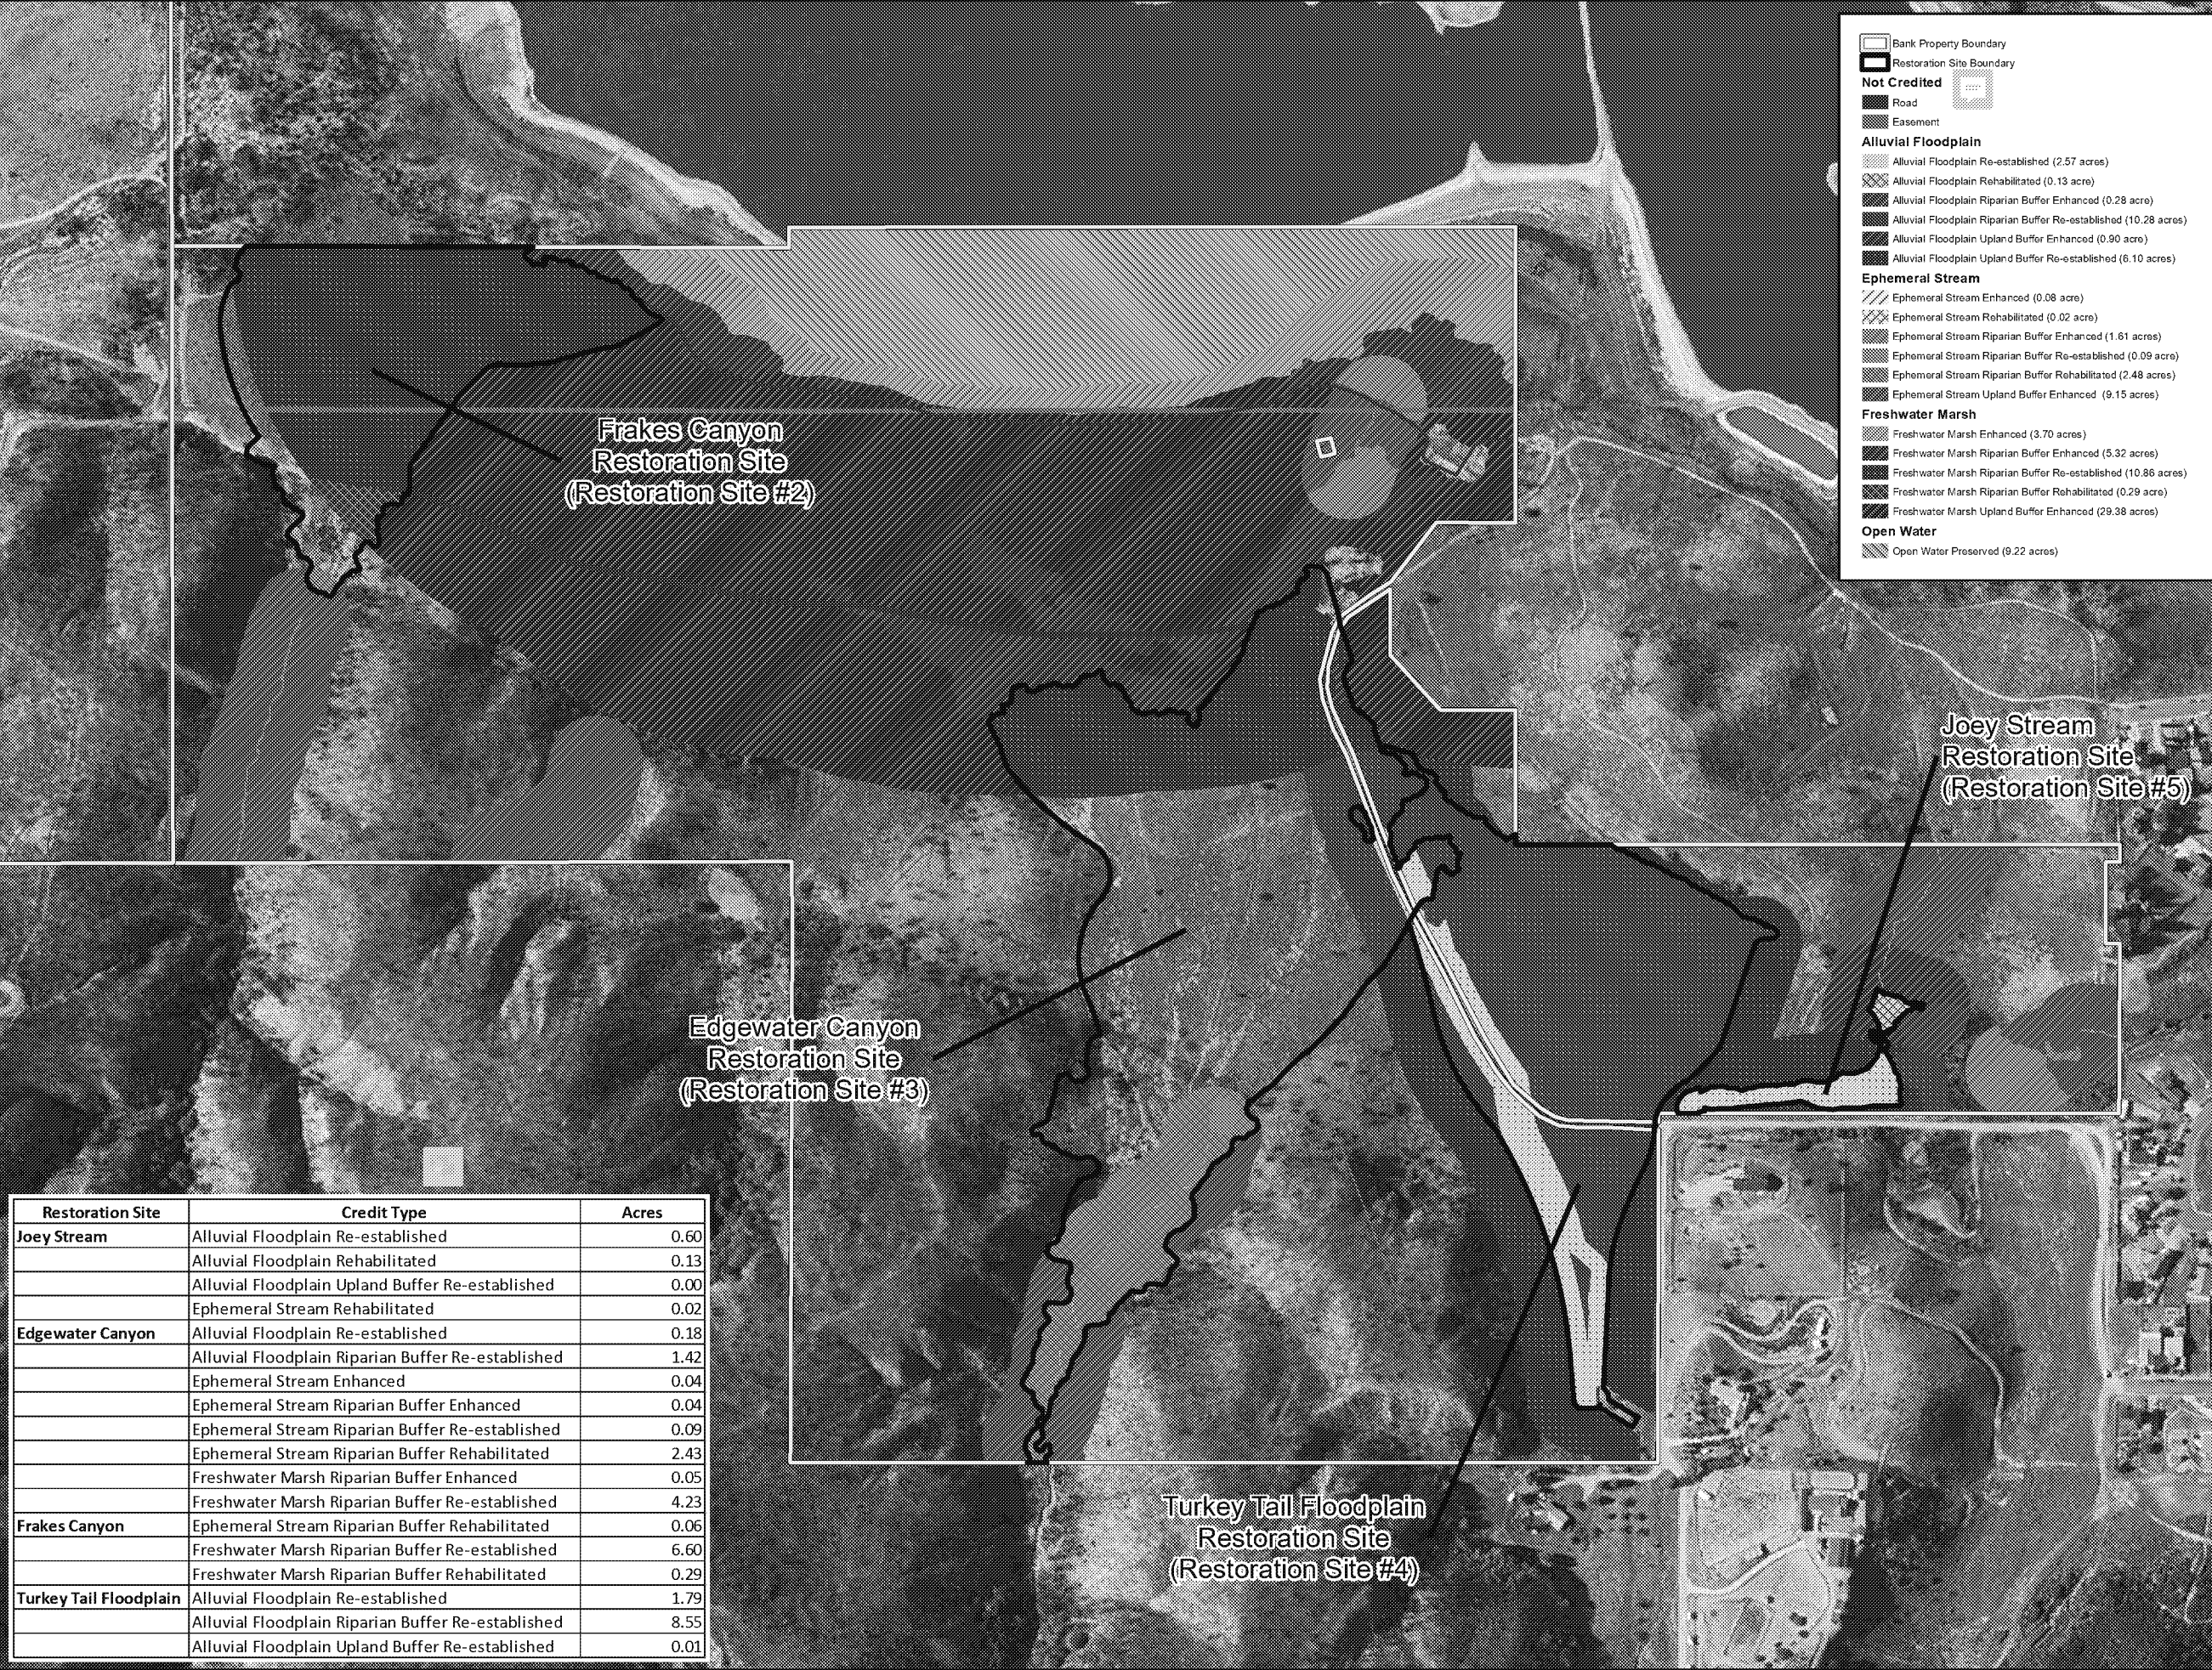
Figure 63.

Path: L:\Acad 2000 Files\21000\21065\gis 2015\ArcMap\BEI Final\Exhibit C\Part VII\Figure 63 Area F - 404 Credits Elizabeth Lake Property 20160310.mxd

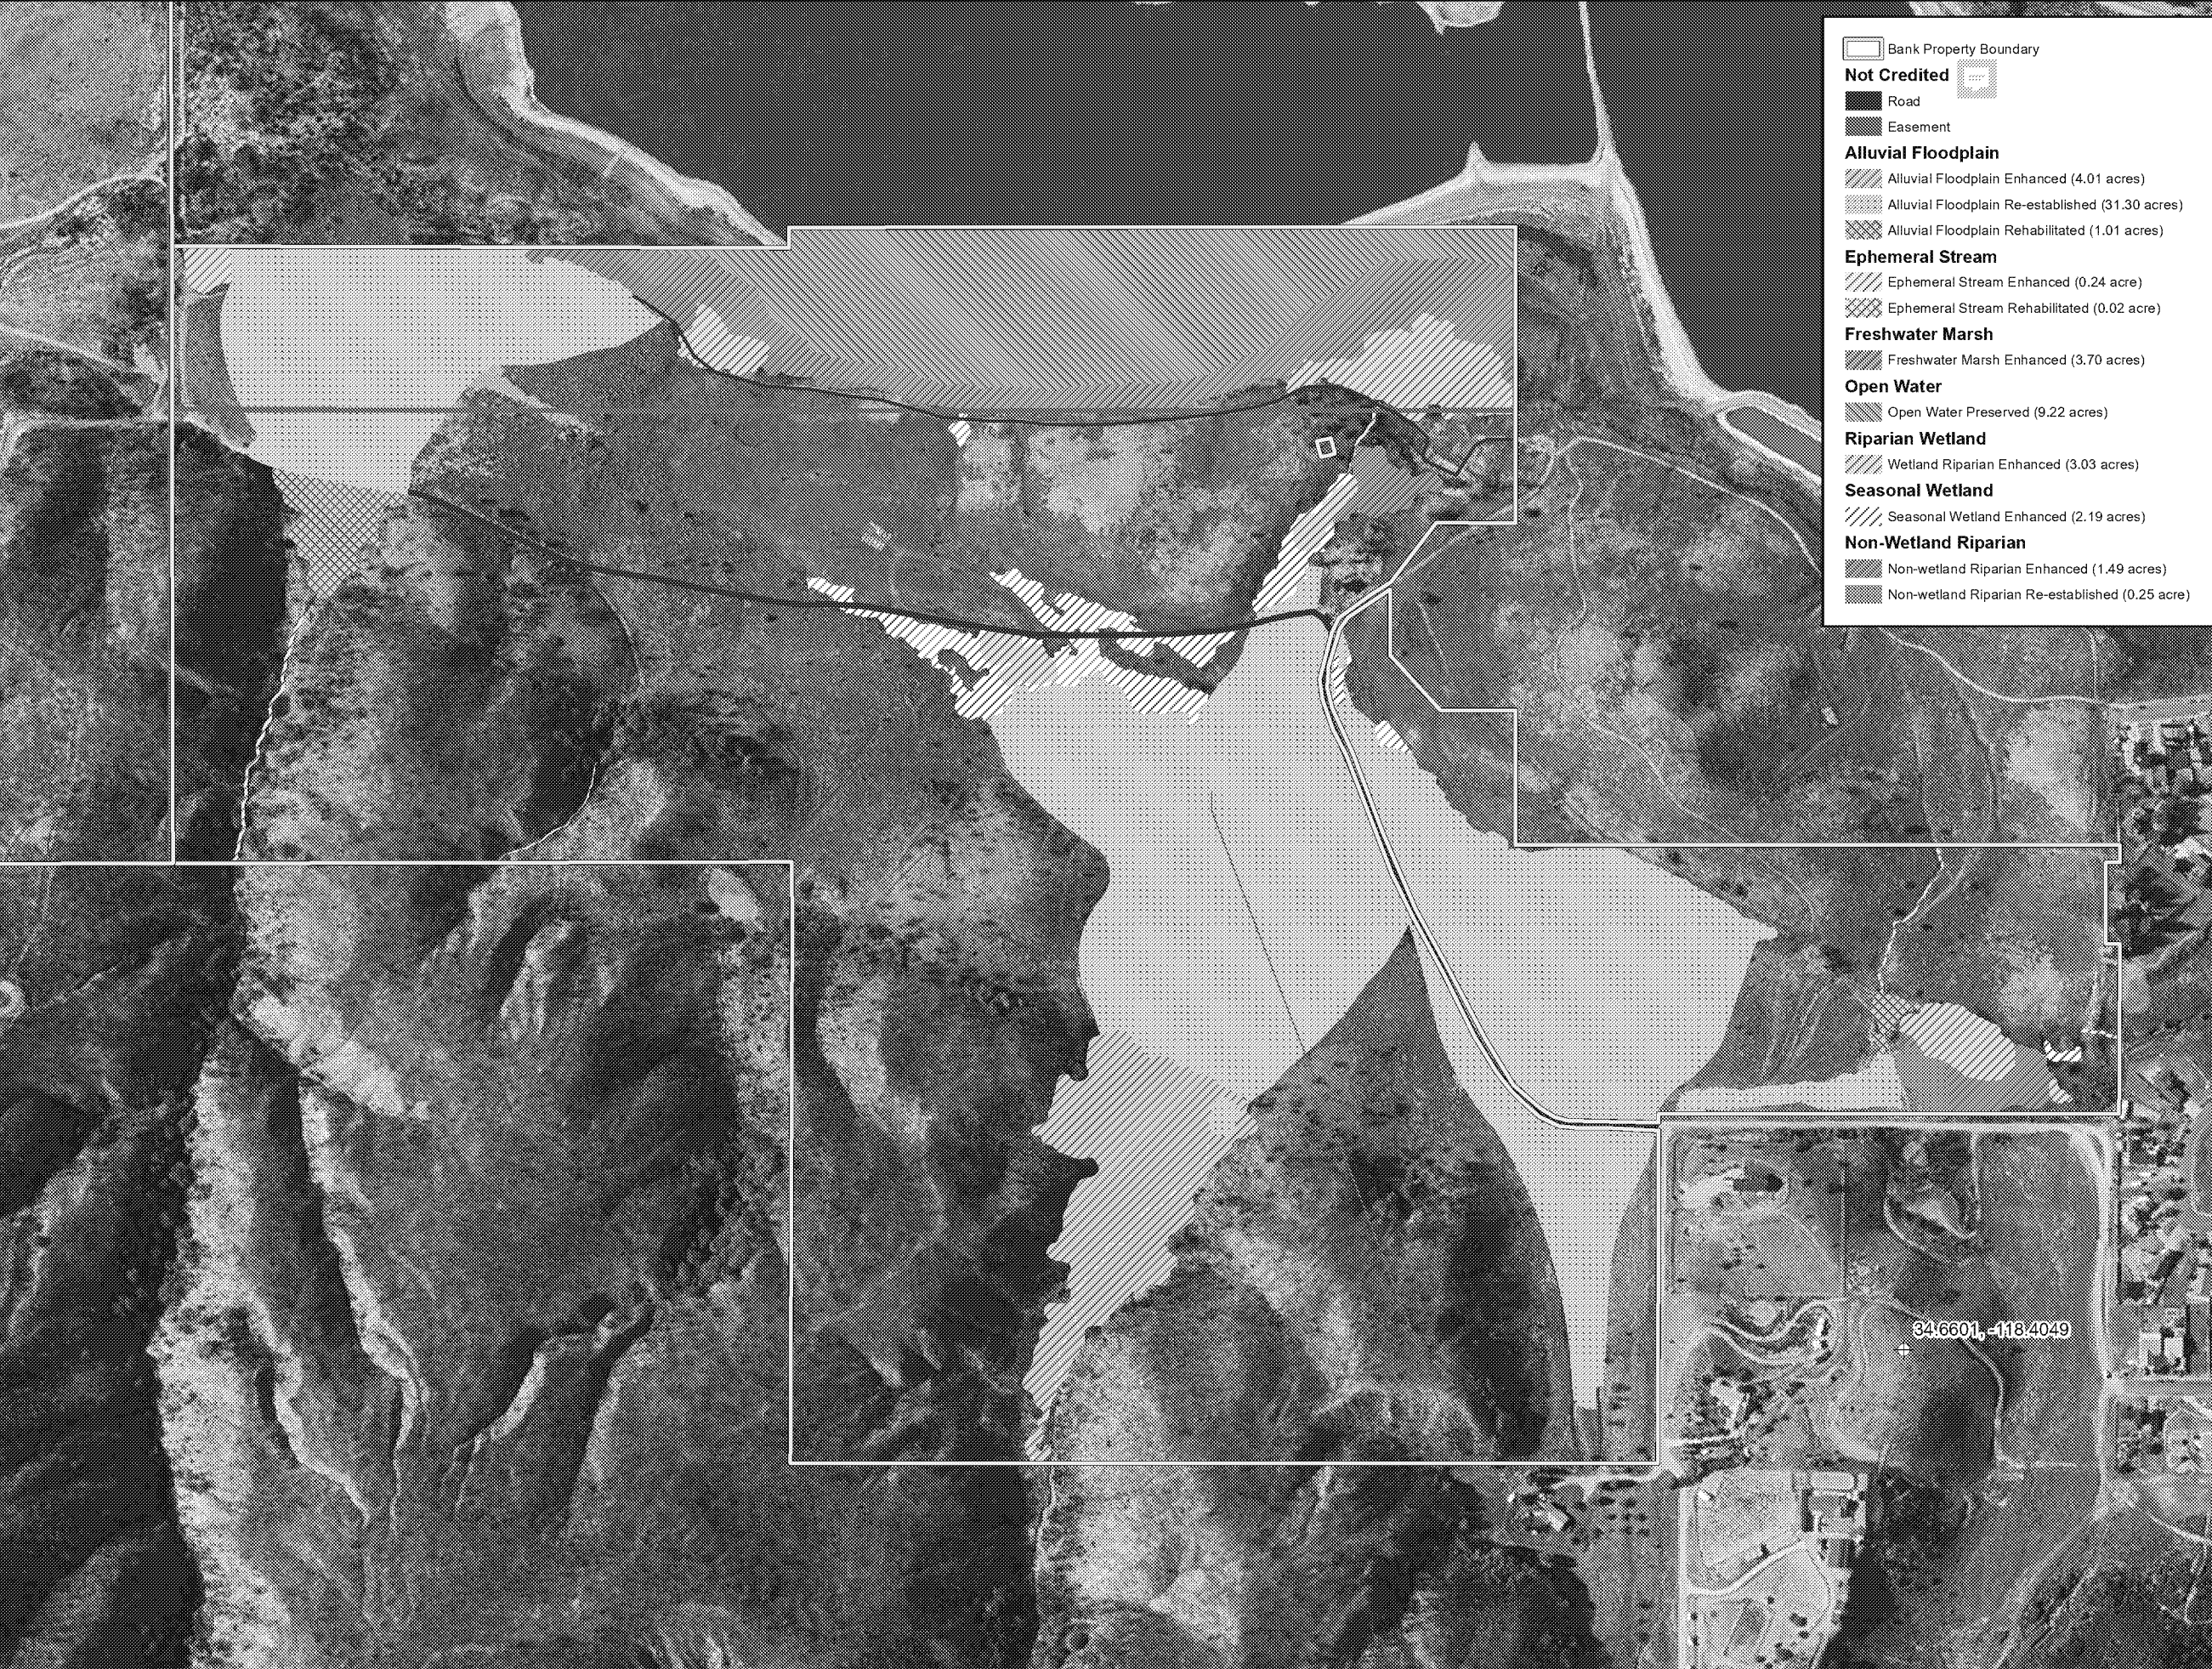
Figure 64.

Area F - 1600
Mitigation Types

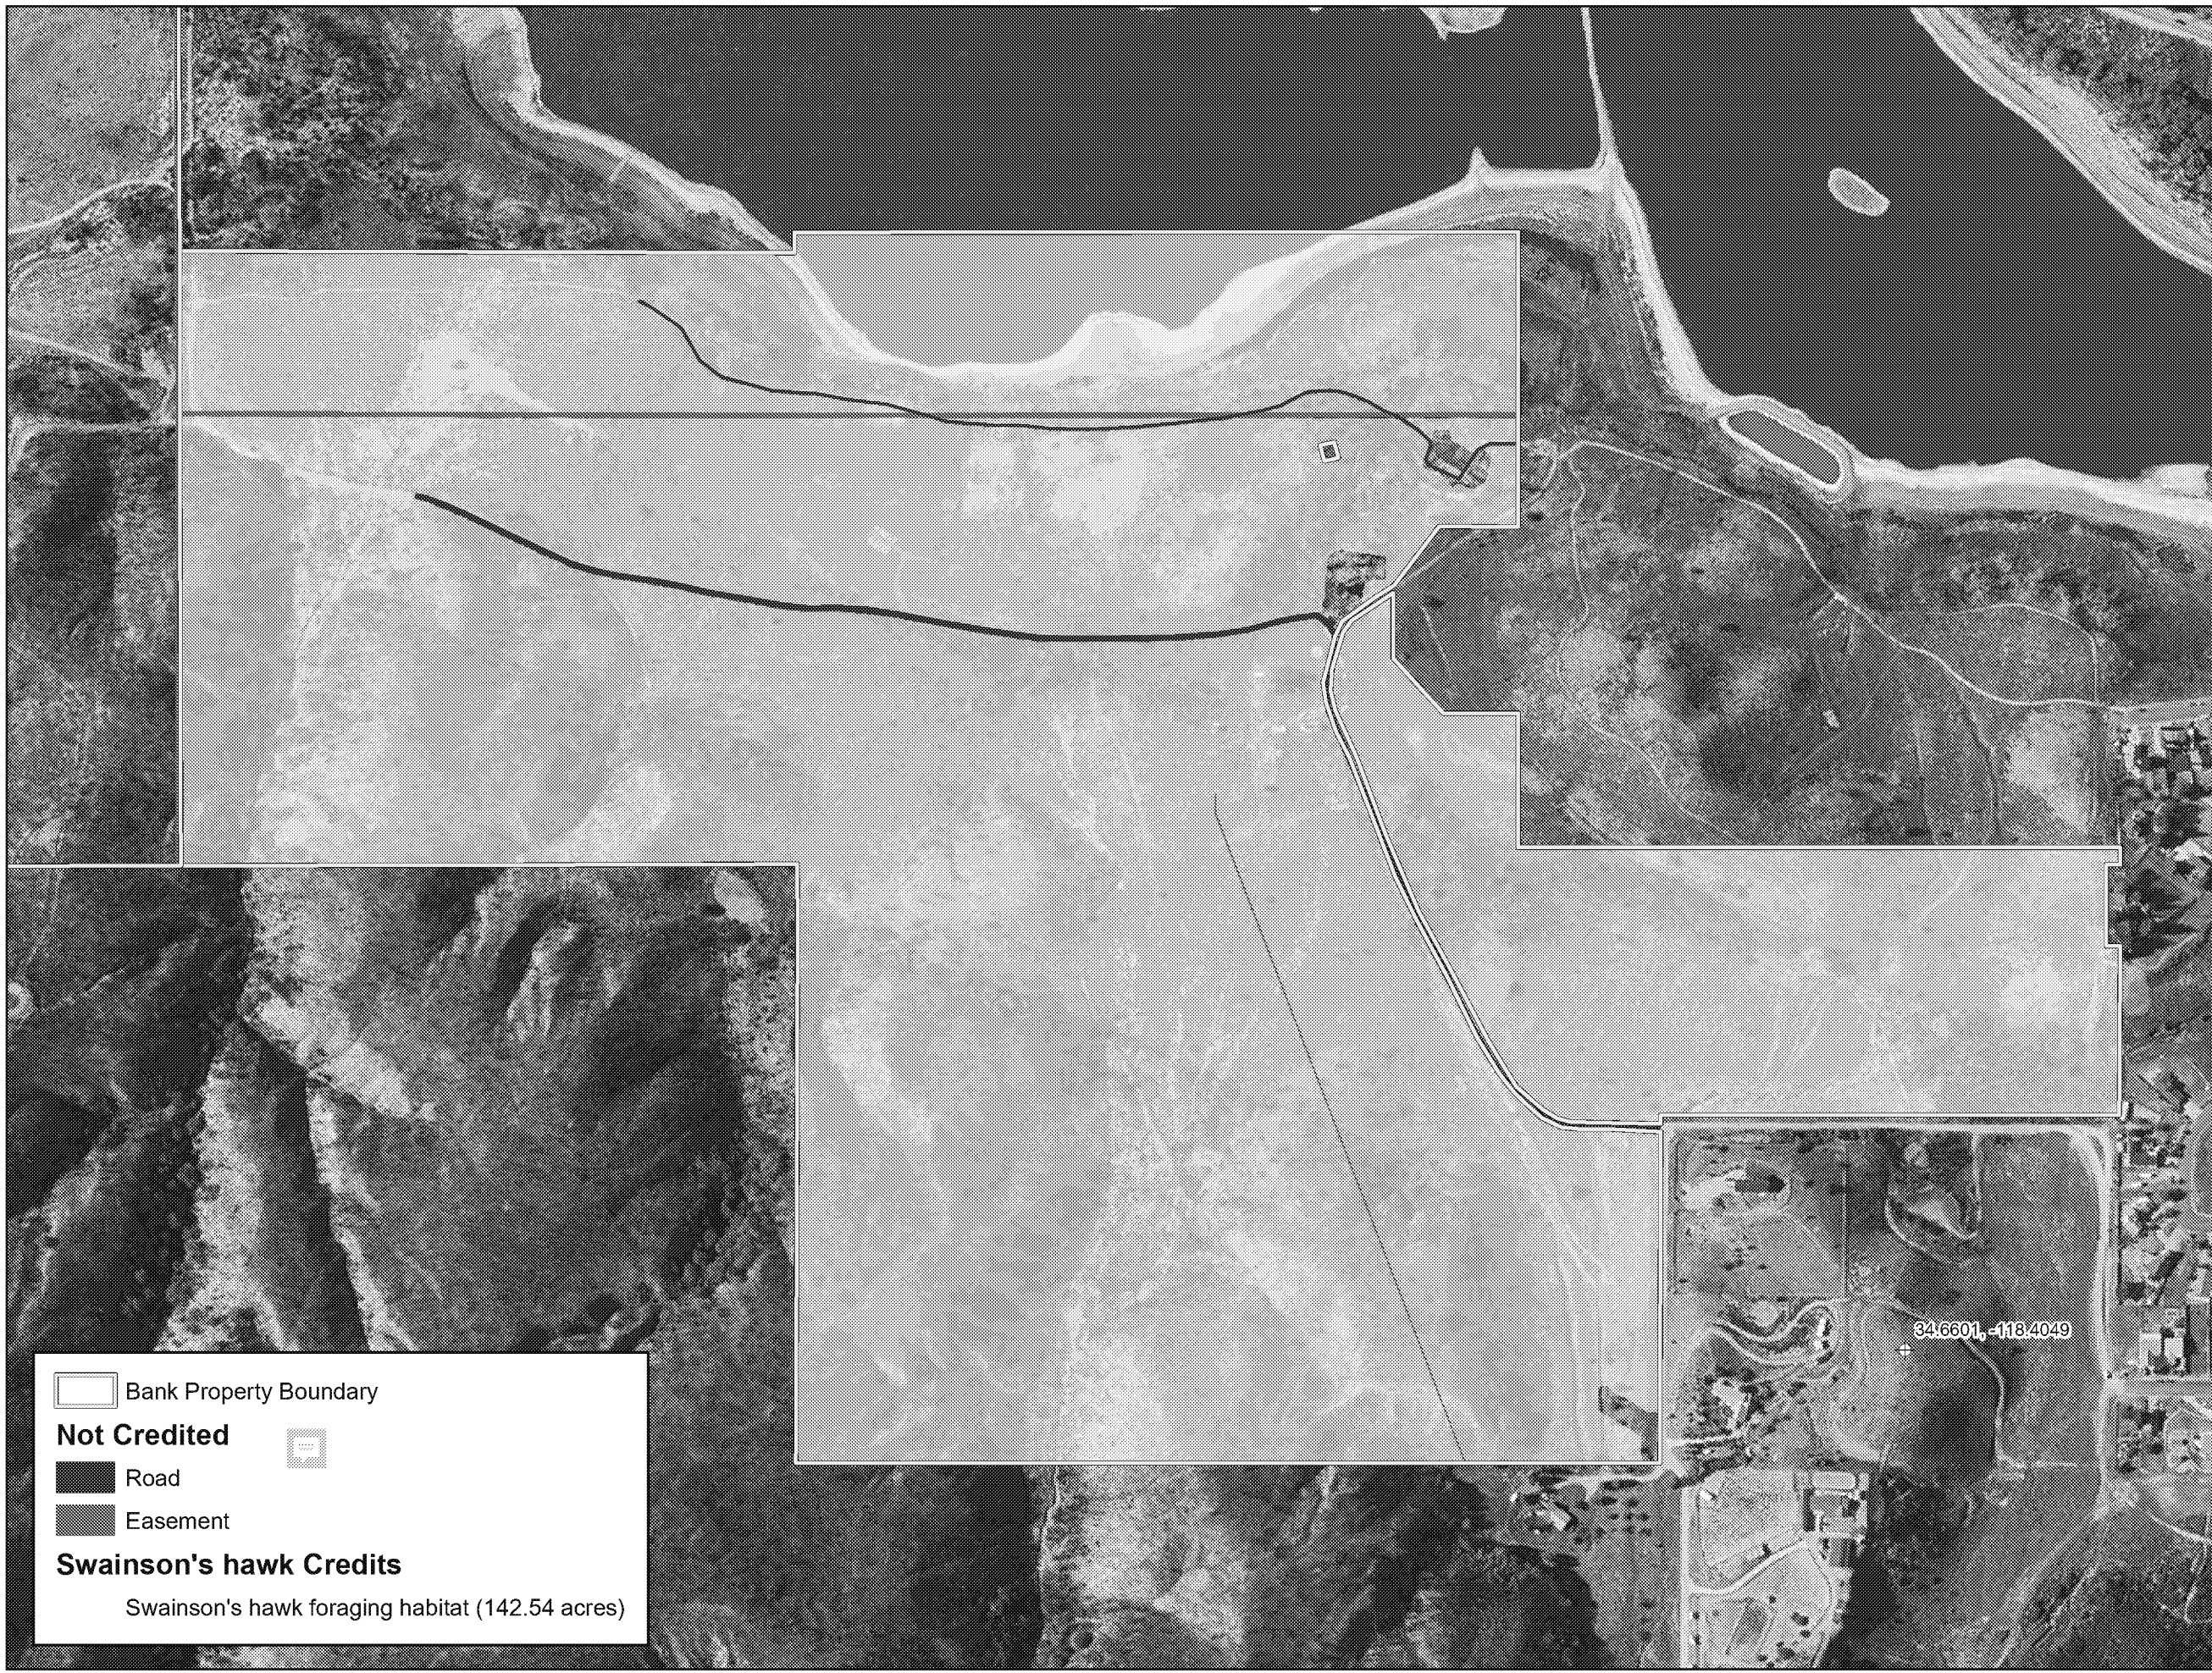
Figure 66.

Area F - Swainson's Hawk
Mitigation Types

Swainson's hawk foraging habitat (142.54 acres)
